Category: Tech | Published: Saturday, 28 June 2014 22:05 | Written by Steve H. | Hits: 3024

I attempted to open the top of the signals/horn push on the steering column. I removed three brass bolts to try and get to the internals, but I don't see how things come apart. Now I can't give up because the three bolts won't re thread. Can anyone tell me how this should open up?

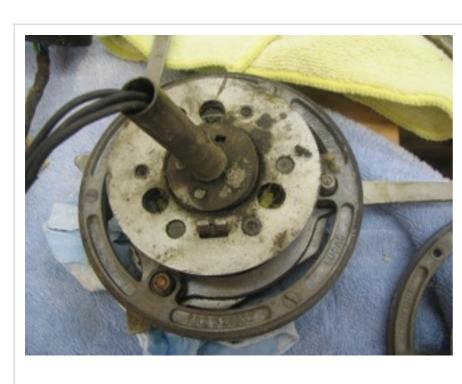
tube removed. Note the three holes to access the screws that hold the assembly together.

The back of the turn signal assembly with the long stator

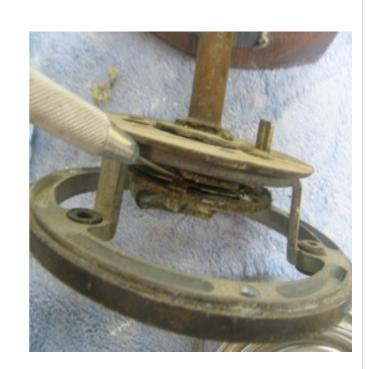
rotated to expose the three screws that hold the assembly together

Thin brass cover plate that has to be

small screws that align through the holes in the back of the assembly and remove the screws.

Like the pictures show, use a small thin screw driver to push this brass plate around until you can see three

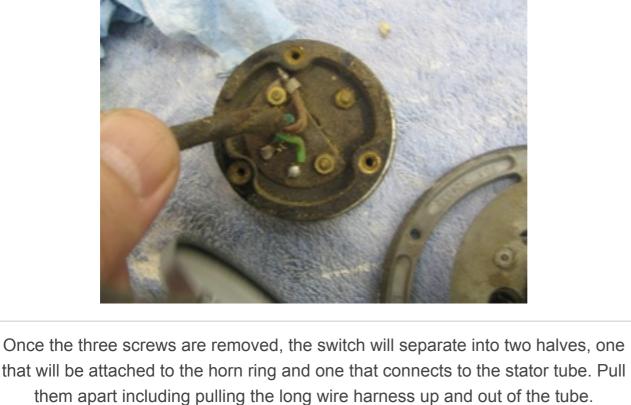
The reason you can't get the three small screws/nuts that you loosened on top to re-tighten is because they

screws you loosened...

are through posts with nuts on the other end - the three nuts are visible in this photo. This would be a great time to replace the stator tube harness! The 4 wires can be un-soldered from their terminals and replaced the same way. Note: due to the tight confines of the tube, the wires really need to be 16 AWG and bundled quite tightly and smoothly so that it will fit down inside the stator tube easily. The harness available from Lou/Autosparks/British Wiring is specifically designed and built to do this and works a treat. This is also a very good time to determine which wire does what. There should be a solid "normal" green (#17) to feed power, a "light" green (#66) that feeds the green/yellow wire in the main harness which activates the RH side of the signal relay and RH signal lights (a good continuity tester/multi-meter comes in VERY handy here...), a "dark" green (#65) that feeds the green/blue wire in the harness which feeds the LH side of the relay/signal lights etc. and a brown wire that feeds power to the louden-honken horns. 5) After you have all of that bit sorted and the screws/nuts re-tightened, it is time to reassemble. First, start by re-attaching the halves of the signal switch, remembering (of course) to thread the wire bundle back

- down through the stator tube. 6) Stick the bundle back down the steering column and thread the stator tube assembly back down the column so that the horn ring etc. seats fully, align the bars on the horn push with the spokes on the steering
